**Quarterly Progress Report**

**Grant #7310006**

**Arctic Thermal Shutters and Doors**

**Arctic Sun, LLC**

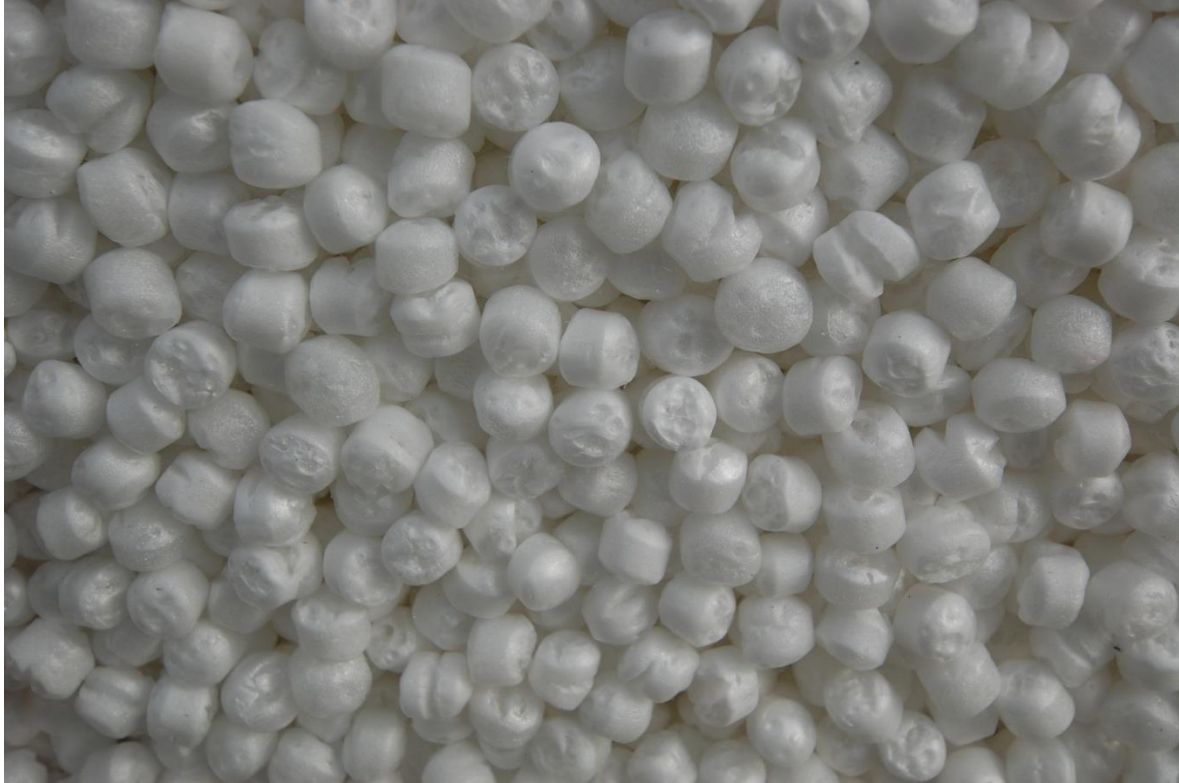
We evaluated each product's ability to be blown; production of static; ability to be vacated from the cavity; UV stability; R-value; availability; and cost. Our final choice was to utilize short cylindrical beads of solid expanded polystyrene (EPS) 9mm in diameter and 6mm long (photo below). These beads are inexpensive, readily available and perform exceptionally well in all parameters tested.

With the superior performance of the EPS beads in almost all tests, we are satisfied they are the best product for this shutter application. Beads of smaller dimensions tended to produce more static and proved more difficult to vacate from the void. The photo below illustrates severe static cling with black beads stuck all over the glass, failing to vacate the test chamber.

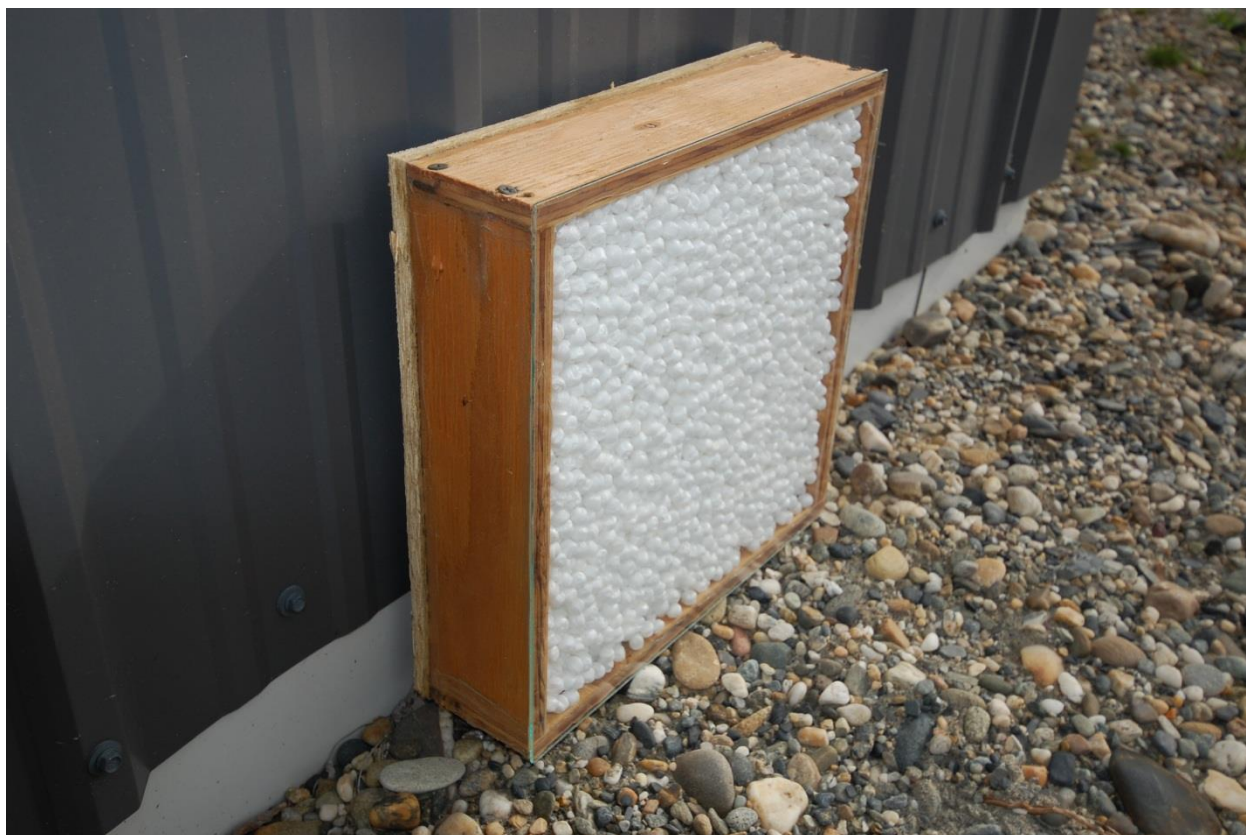
We are still performing a UV stability test with the EPS beads. The beads were loosely placed within a small glass-sided box, as they would be blown into a cavity utilizing the final design. This window was then placed outside on June 28<sup>th</sup>, facing south with full exposure to the sun (photo below).

We'll leave this in place all summer and document any changes to the beads as a result of this solar exposure. As of July 24<sup>th</sup> there were no significant changes noted.
